Inspection Report Minerals Regulatory Program Report Date: November 24, 2004

Mine Name: Red Chief Permit number: S/015/083 **Operator or Permittee Name:** Inspection Date: November 18, 2004 Quality Building Stone Permittee Mailing Address: 993 West 14730 South, Bluffdale, UT 84065 Weather: Mostly clear, 40's **Inspection Start Time: 2:20 PM Inspector(s)**: Paul Baker **Inspection End Time:** 2:35 PM Other Participants: None Site location/Area Inspected (i.e. Pit #): Entire area Permit Status: Inactive Surface Ownership: SITLA **Current Acreages:** Mineral Ownership: SITLA Total Permitted (Bonded): 4 Mineral Mined: Stone Total Disturbed: Exact acreage not known; about 1-Type of Mine: Surface 2 acres disturbed

Photographs S/015/083, Red Chief, Quality Building Stone

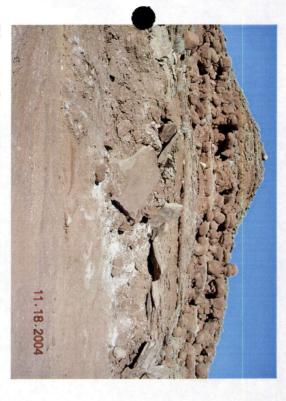
Photo 1. Some disturbance on the east side of the crossing shown in Photo 2,

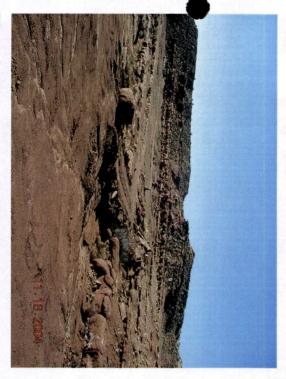
Photo 2 shows a small drainage that was blocked to create access to the main part of the quarry. If the quarry was going to remain for an extended time, I would recommend a culvert be placed in this drainage.

Photo 2. Drainage crossing. Note the large rock restricting access.

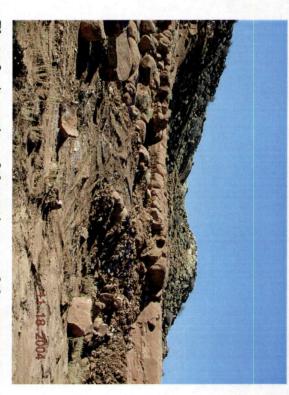
Photo 3. A portion of the main part of the quarry.

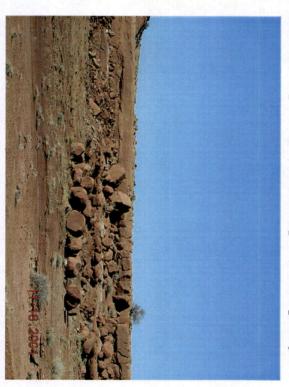
Photo 4. Stockpiled rocks in the main part of the quarry.
